Studebaker

SERVICE BULLETIN

NO. 314

1956

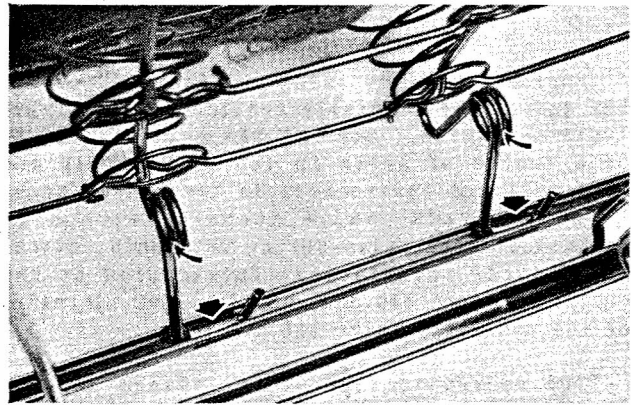
FIG. 1

If a squeak in a seat cushion is encountered, it is probable that it originates at the jack springs (see Fig. 1), either at the pivot point or where the coils rub together.

A lubricant such as "Lubriplate" may be used at these points to eliminate the squeak without soiling upholstery.

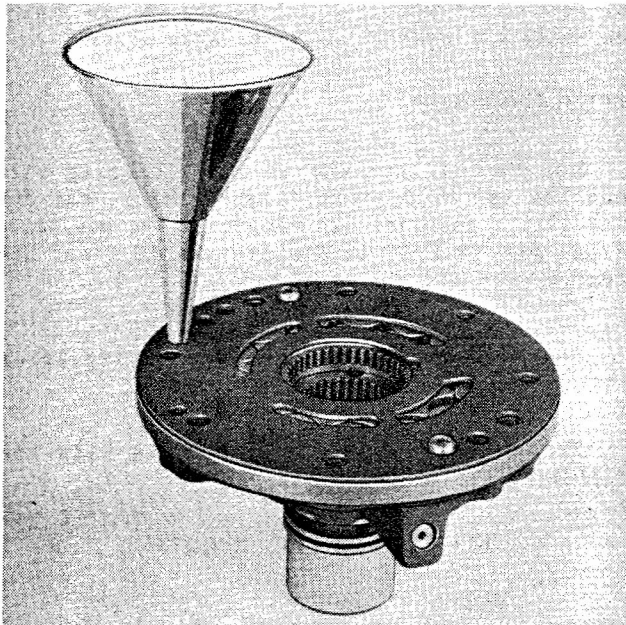
FIG. 2

A few cases have been found of a restriction in the high range clutch oil passage in the front pump of Ultramatic transmissions. This restriction is caused by the core shifting when

the pump housings are cast. If the passage is restricted, possible engine raceaway on low range converter to high range converter upshifts may occur, or the high range clutch may burn out prematurely.

Place the complete front pump assembly in a shallow pan with the pump plate upward and in a horizontal position. Use a small funnel with the end reworked to obtain a close fit in the high range oil circuit hole of the pump plate as shown in Fig. 2.

Use only Automatic Transmission Fluid during the test. To obtain accurate results, it is important that the temperature of the fluid is between 65° F. and 75° F. Pour enough fluid in the funnel to fill the high range passage in the pump, allow the fluid to drain down to a level slightly above the funnel spout. At this time, pour an additional 1/2 pint of transmission fluid in the funnel and observe the time required for the fluid level to reach the predetermined level.

If it requires more than 2 minutes and 15 seconds for passage of the 1/2 pint of fluid, it will indicate the passage is restricted and the pump should be replaced. Repeat the test if restriction is indicated before replacing the pump.

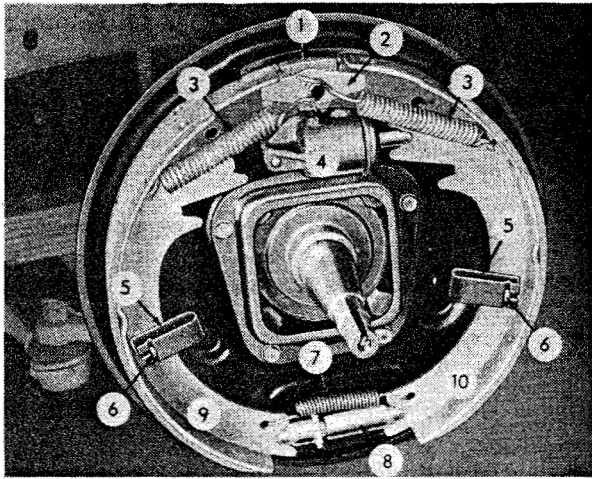
FIG. 3

A Wagner self-energizing type brake with a star wheel adjustment between the lower ends of

the shoes is now being used. The front brake has the single piston in the wheel cylinder, the rear brake two pistons in the wheel cylinder. This is the same type brake used on the 2E13 model (see Figs. 3 and 4). Servicing procedures are the same as described for the 2E13 model.
