Studebaker

SERVICE BULLETIN

NO. 315

1956

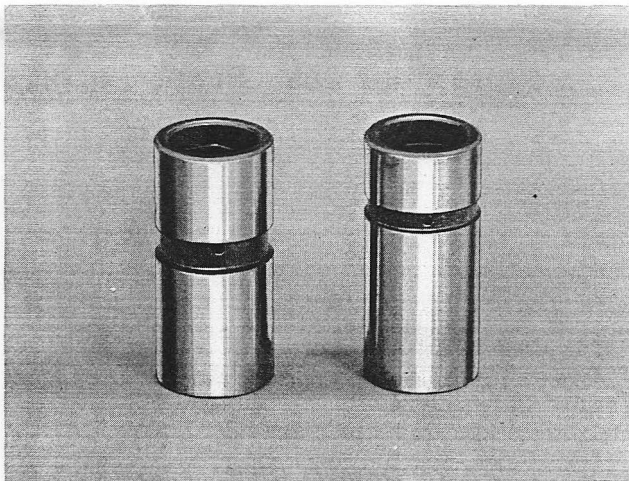
FIG. 1

The new valve lifters, having the greater oil reservoir, have a narrower oil groove in the body and the groove is raised slightly as shown by the right hand lifter in Fig. 1.

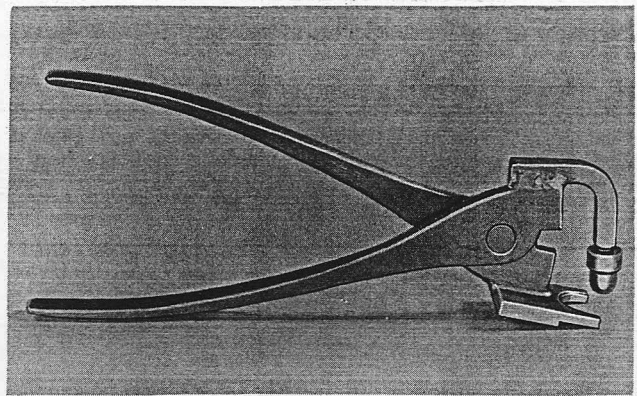
FIG. 2

Figure 2 illustrates the new tool J-5978-A that will test either type lifter.

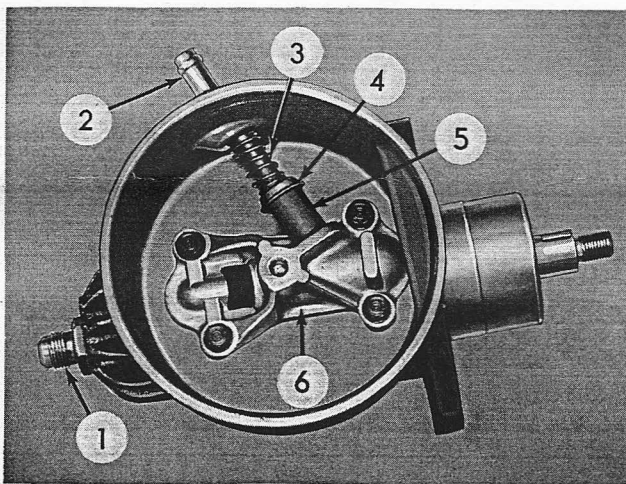
FIG. 5

assembly can readily be identified because the hydraulic return hose is attached to a tube in the reservoir, rather than to the pump cover assembly. Further, the return hose no longer uses high pressure fittings; it is assembled with wrap-around hose clamps. This pump has a small screen (5, Fig. 5) located in the reservoir to filter the oil as it is returned.

The return tube (2) attached to the reservoir is shorter on the assemblies used on the 56G - W-F-D models than the tube of the unit used on the other models. This is necessary to prevent interference between the return hose and the battery. The unit as received from the Parts Depot will have the longer tube. Therefore, it will be necessary to modify the tube before it is used on the 56G - W-F-D models. Before installation, cut off approximately 1/2" of the tube, using a tube cutter. Every precaution should be taken to prevent chips or foreign matter from entering the return tube.
