SERVICE BULLETIN

OCTOBER

No. 317

1956

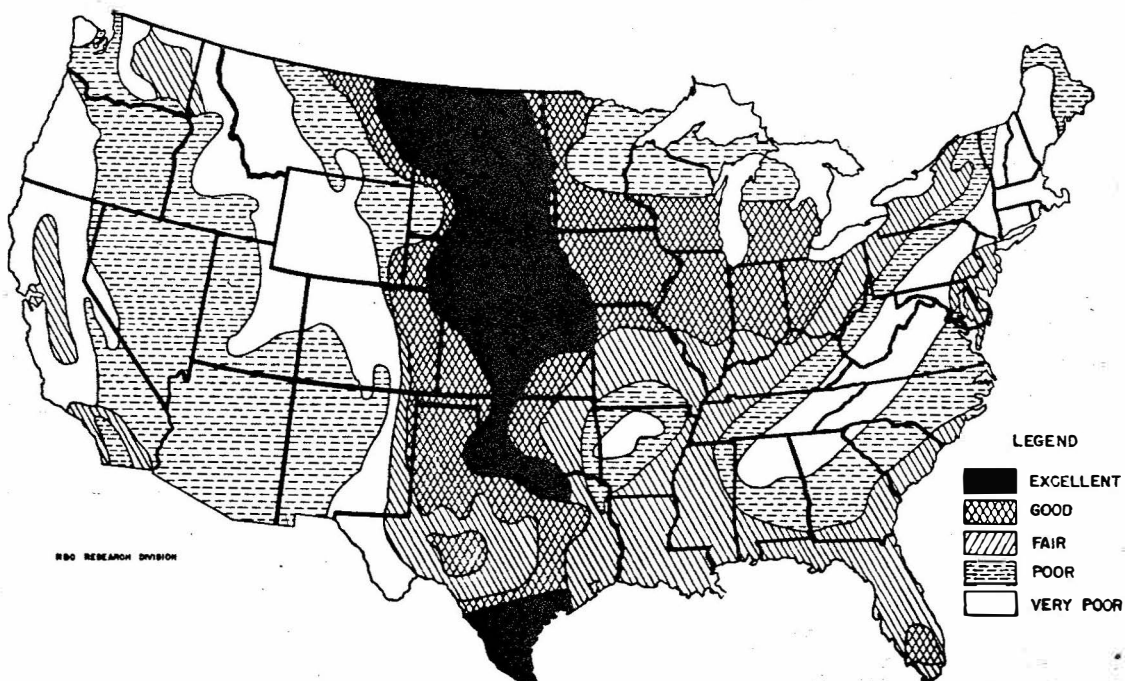
When you receive a radio signal during the daylight hours, the radio wave travels along the surface of the earth and it is constantly affected by the ground over which it passes. The higher the conductivity of the ground, the less it absorbs, and weakens the wave and consequently the better the reception. The conductivity of the ground, which is the result of geological conditions, varies widely throughout the United States, and its affect on transmission is so important that it cannot be ignored. The map below shows the ground conductivity of the country in five broad classifications. Take a look at your locality on this map, and using the legend in the lower right hand corner, see how your area is rated as to quality of reception due to ground conductivity.
