Service Bulletin

AUGUST

1957

NO. 327

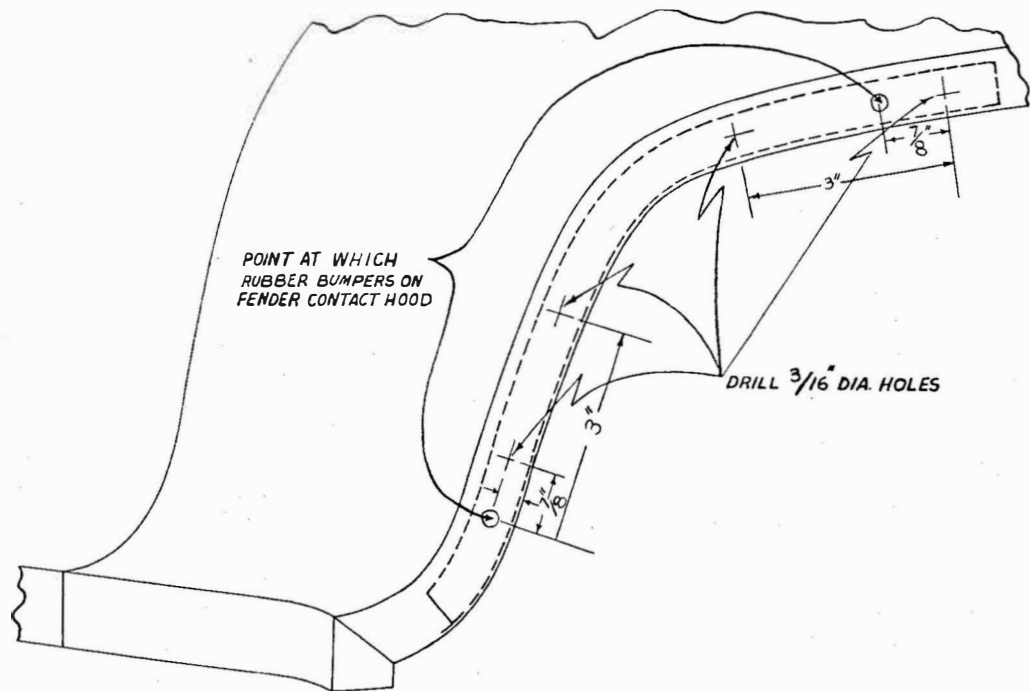
Fig. 1

Reinforcements are now being added in production to the hoods of all sedans and station wagons. A reinforcement is located in each side flange near the front corner. Although the reinforcements are being welded in production, they may be installed in the field by using small bolts and nuts. However, a flat oval-head bolt must be used to prevent interference at the fender when the hood is closed.

Layout and center-punch the hole locations

on the hood flange to the dimensions shown in Fig. 1. Then, drill the holes with a 3/16" diameter drill. The bracket may be held in position on the flange with lock-type pliers and, the flange and bracket drilled at the same time. After installation of the bracket, check the clearance between the bolt heads and the fender. Provide clearance if necessary, by carefully striking the head of the bolt with a rubber mallet.

The following parts are required:

- 1 - 1320686 Bracket, right
- 1 - 1320687 Bracket, left
- 8 - 2055X1 Bolts
- 8 - G271166 Nuts

After completing the installation, paint the brackets.

The operation number and estimated time required are: Operation V-72 - Install hood reinforcements, includes painting. Time - 0.6 hours.

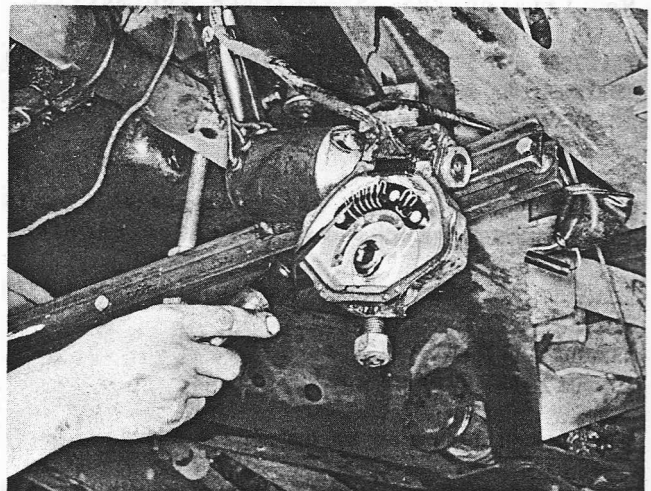
Fig. 2

In most cases of malfunctioning of the Ultramatic push button control, the trouble is found in the contact finger and lead assembly of the actuator.

Unless there is an obvious failure of a component unit or relay in the system, the over-all check through the complete circuits to the fingers of the actuator is the most positive check for the source of trouble. The suggested method of checking described below, will reduce the danger of overloading or burning out the control units in the system that are operating satisfactorily and prevent overtravel of the segment with its resultant difficulties by eliminating the hit and miss method of applying jumper wires at the control units in an effort to diagnose the trouble.

Method of Checking -- Disconnect one of the cables from the battery. Disconnect the wires from the pressure switch and join them with a connector; all other wiring must remain connected. Remove the motor and actuator as described in the Packard Service Manual. Mount

the assembly on the engine support bar or some suitable location to make it accessible and to provide a good ground. (See Fig. 2). Wipe all loose dirt from the unit, and remove the actuator cover. Connect the battery cable.

Operate the controls through the push buttons in the regular way and observe the functioning of the fingers and sector. If the sector, for example, will operate to D position and then refuses to move, use a test lamp grounded to the engine and touch the D finger to see if the lamp will light. This will insure that current is flowing to that finger. Obviously, if the test lamp does not light, the trouble is in the circuit before this point. If it does light, the trouble is caused by a poor contact of the finger on the segment. Press the finger tightly against the segment, if the contact is good, depressing another button will change the sector position to the button depressed.

Remove the contact finger assembly and check the finger or fingers that are not making good contact on the segment. If the finger assembly is in good condition, bend the finger or fingers just enough to provide proper bearing on the segment. When the fingers are properly aligned on their support they should have a contour to conform to the segment. This alignment should also be checked every time a new finger assembly is installed.

If there is evidence of shorting or a previous bad arcing condition at any of the fingers, causing the fingers to lose their tension, the contact finger and lead assembly should be replaced.

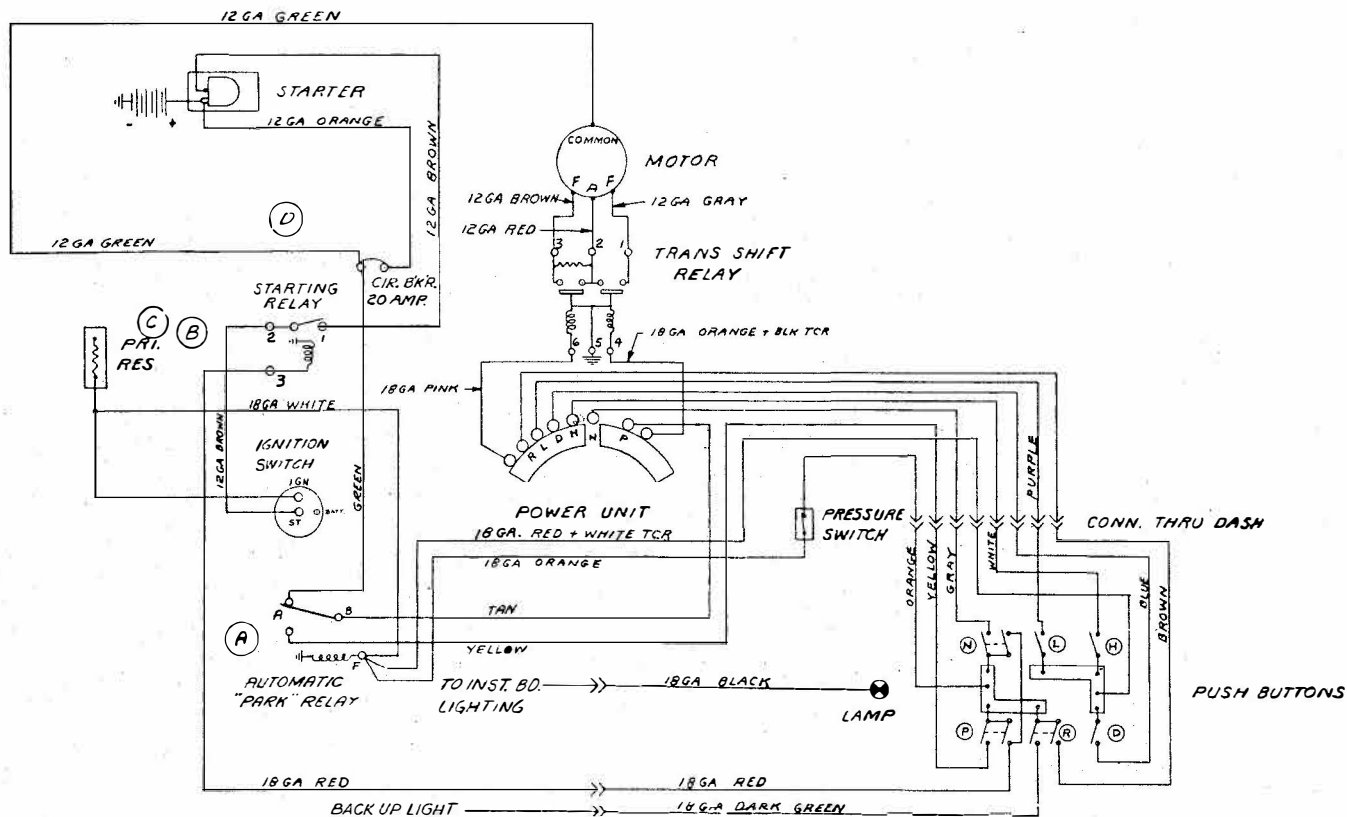
Fig. 3 WIRING DIAGRAM OF PUSH BUTTON SYSTEM

If the trouble is not caused by a faulty finger contact the test lamp will enable you to

determine to which circuit the trouble is confined and trace the circuit or circuits involved to find and correct the trouble. Fig. 3 illustrates a schematic wiring diagram of the system.
