Service Bulletin

NOVEMBER 1957 NO. 331

SOUTH BEND 27, INDIANA

CARBURETOR AIR CHAMBER BASE -- 1957 GOLDEN HAWK AND PACKARD CLIPPER MODELS

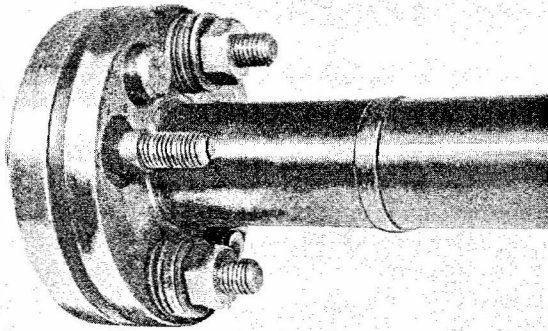
Fig. 1

2. Remove the steering gear post from the jacket assembly. Assemble the old steering gear shaft flange to the post using a new lower rubber insulator between the two flanges. Be sure that the "T" marks on the steering post flange, the steering gear flange and the rubber insulator are aligned before assembly. Using sufficient quantity of flat washers (5/16 x 9/16) so that the two flanges can be secured together, install and tighten the nuts on two of the flange studs (see Fig. 1).

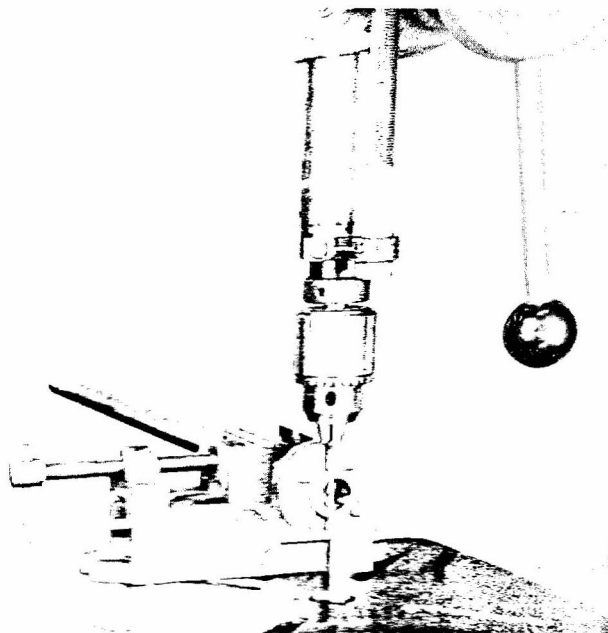
Fig. 2

3. Using a drill press vise or V blocks and clamps to hold the assembly, place the assembly on the drill press table. Insert a 3/16" drill bit in the drill chuck. Then, use the drill bit as a guide, position the assembly so that the drill is aligned with the hole in the old flange. See Fig. 2. Fasten the assembly securely to the drill press table.

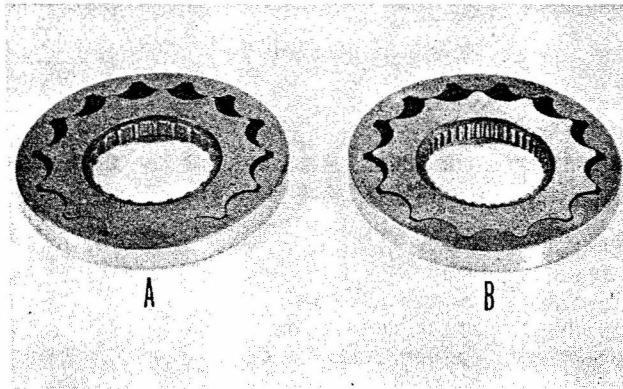
Fig. 3
A. 20 Spline Rotor
B. 40 Spline Rotor

When the converter shaft assembly of the gear-start type Ultramatic transmission is replaced because of worn or stripped splines, it is advisable to check the front oil pump rotor. If the rotor is one having 20 teeth in the driving section, replace it with one having 40 teeth, Part No. 6489367. Whenever it is necessary to replace both the shaft and rotor, it is advisable to order either Part No. 6484523, Rotor and Shaft Kit, or Part No. 6484524, Pump Assembly and Shaft Kit. This will insure lon-

The front oil pump rotor ('A' in Fig. 3) having 20 internal splines is used in the 54th

Series Gear-Start, 55th and early 56th Series. 'B' shown in Fig. 3 is the 40 tooth splined rotor, Part No. 6489367.

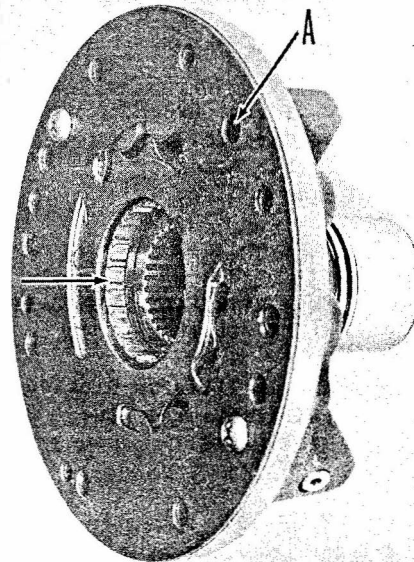
Fig. 4
A. Direct Drive Clutch Oil Pressure Passage

On the 54th Series Gear-Start, all 55th and early 56th Series Packard and Clipper models, the oil pressure for the direct drive clutch came out of a passage on the front side of the pump. See A, Fig. 4. The oil pressure was

directed through a passage in the bell housing then past the open splines in the rotor to the input shaft.

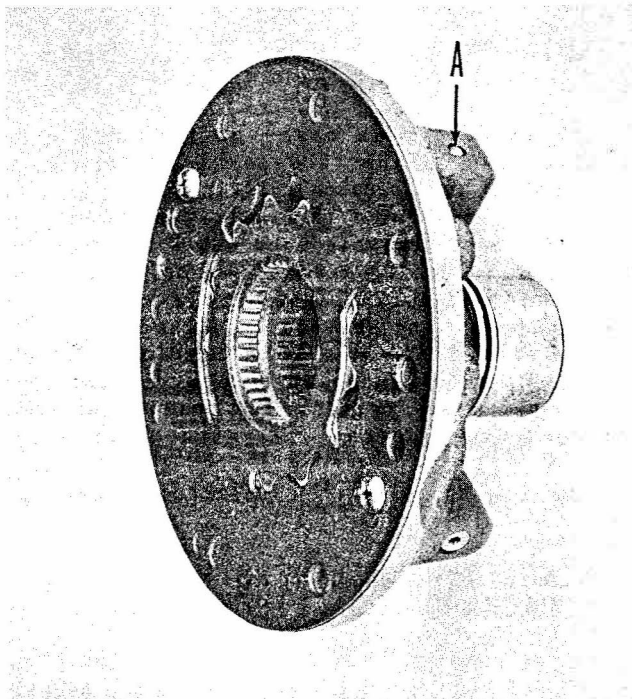
Fig. 5

On the 56th Series Packard transmission after transmission serial number 5-40469, and all Studebaker 56J Golden Hawks, the front oil pumps have the direct drive clutch oil passage in the rear side of the pump. See at A in Fig. 5. The outlet for this passage is in between the two bushings inside the pump hub. Note that there is no oil passage in the front plate. However, this type pump originally had the 20 tooth splined rotor. (40 tooth shown in the illustration)

A. Direct Drive Clutch Oil Pressure Passage

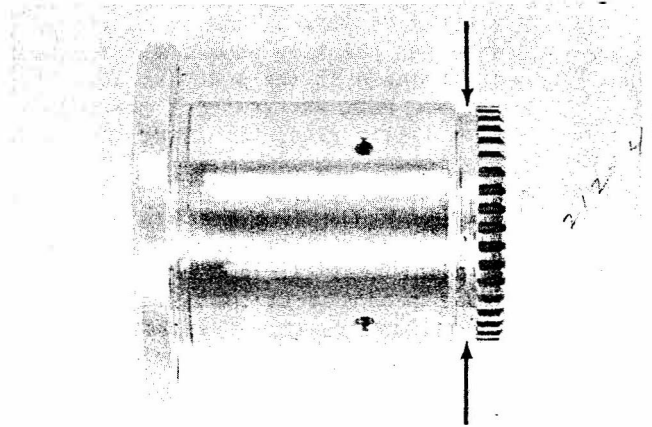
Fig. 6

The pump assembly listed above has the oil passage in the front side of body and the rotor

has 40 splines, therefore, it will be necessary to drill six 1/8" holes evenly spaced through the annular groove just back of the splines in the converter shaft to provide an oil passage to the direct drive clutch. "See arrows Fig. 6." This also applies when replacing the rotor assembly. When necessary to drill holes in the groove of the converter shaft, remove burrs from the edges of the 1/8" holes and internal bushing after drilling.

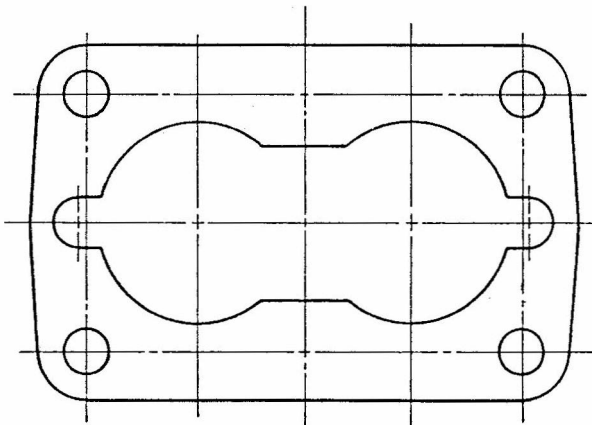
Fig. 7

(a) It has been found that an improper gasket has been installed below the carburetor that either restricted or entirely cut off the vacuum to the vacuum-solenoid control assembly. With no vacuum acting on the control diaphragm, the downshift and throttle valves are held wide open. As a result, high control oil pressure and, high and rough upshift points will be experienced.

Carburetor Gasket, Part No. 1540006, (see Fig. 7) must be used with the Warner Gear Automatic Transmission.

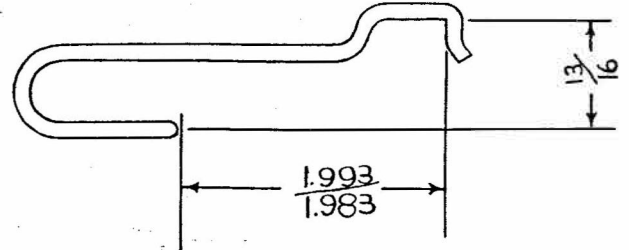
Fig. 8

(b) Also check the Downshift and Throttle Valve Control Hook, Part No. 1687316, for distortion. Should this hook be distorted it will change the relative position of the downshift and throttle valves and thereby affect control pressure.

If the control hook has "opened-up" (see Fig. 8), it can allow the downshift valve to come out of its bore far enough to cock and not re-enter the bore correctly. When this happens the downshift and throttle valves will not respond to adjustments of the vacuum-solenoid control assembly and control pressure will be abnormally low.

To check for this condition, remove the vacuum-solenoid control assembly. Insert a length of 1/8" rod directly against the control hook rocker arm. Pressure against the rod should cause the downshift valve to move inward. If the rocker arm cannot be moved in this manner, it indicates the downshift valve is sticking. In this case, remove the control valve assembly and check the control hook, downshift valve, and throttle valve.
