# Service Bulletin

JANUARY

1958

NO. 333

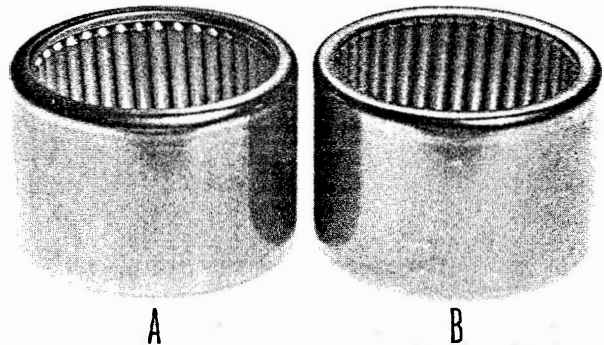
Fig. 1

The steering knuckle needle bearings used on 1958 Model Studebaker and Packard passenger cars are not held in their case on the ends. The rollers are flat on the end and the case is not crimped over their ends (see B in Fig. 1). Care must be taken during disassembly not to

allow the needle bearings to come out of the case.

The service bearings, Part No. 196859, have the case crimped to prevent the bearings from coming out of the case (see A in Fig. 1).

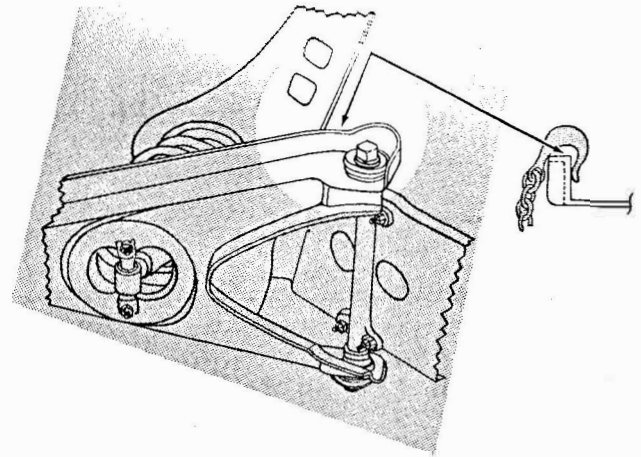
Fig. 2

It has been brought to our attention that the operators of auto wash stations have been hooking a tow chain or hook to the front stabilizer bar link on 1958 model Studebaker and Packard cars. This results in bending of the link and pulling the bar out of the outer rubber bushing.

Unsatisfactory points for attaching the tow chain are:

1. Stabilizer bar or link because of reasons outlined above.
2. Rearward end of bar. Danger of entering hook into radiator core.
3. Retaining bracket on 58L models. This bracket is designed for vertical loads and is only

held by one bolt. Pulling on this bracket could distort the bracket or turn it out of proper alignment.

The best point of attachment is on the lower support arm near the inner shaft as shown in Fig. 2.

Dealers should make sure that all auto laundries or Hi-Speed Auto Wash Stations in the area are informed of the proper points for attaching the tow chain or hook to avoid damage to the stabilizer bar.

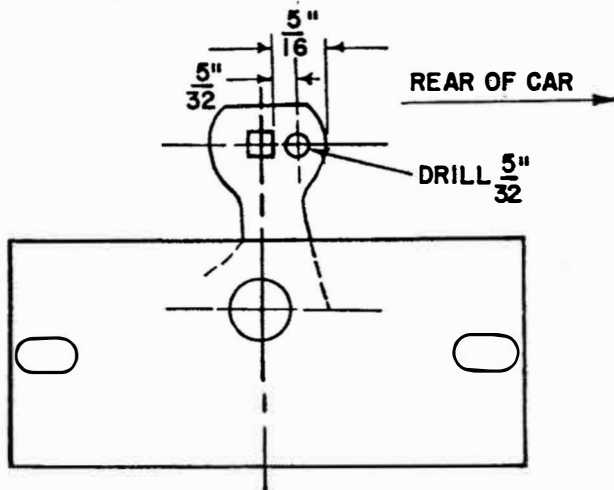
Fig. 3

Occasionally you may encounter binding of the door latch remote control or experience difficulty in locking front doors on 1958 Model Scotsman 4-door sedans after the installation of arm rests. When you find these conditions they can be corrected as follows:

1. Remove the inside door handle and regulator handle. Remove the arm rest and trim panel.
2. Remove the remote control retaining screws and disconnect the remote control wire from the remote control. Remove the control assembly.
3. Relocate the remote control wire hole  $5/32$ " toward the rear of the remote control (see Fig. 3).

4. Connect the remote control wire to the remote control and install the control and retaining screws. Adjust as required.
5. Position the remote control wire in the guide clip and test the remote control and the inside door lock push rod for proper operation.
6. Install trim panel, arm rest, and door and regulator handles.
