# Service Bulletin

MARCH

1958

NO. 335

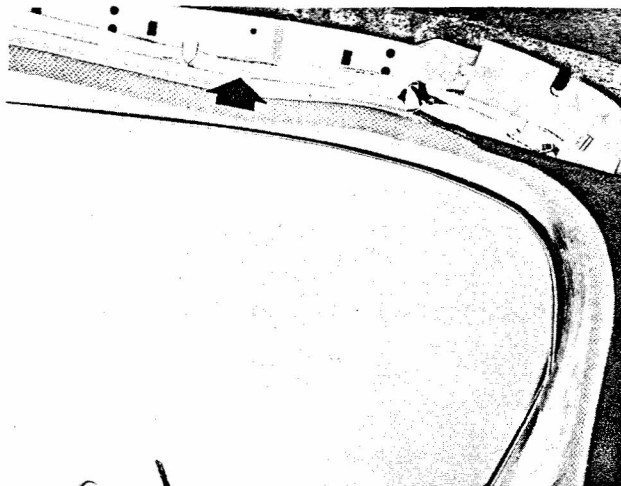
A-804  
 Fig 1  
 ENG. C. No. 37362

The headlining must be unhooked in the area between the second and third rear bows along the windlace to expose the header and locate the position for installation of the Bracket, Part No. 1328032. (See Fig.1) The bracket must be installed directly over the boss located on the header as shown in Fig. 2.

1. Use an awl or ice pick to fish out the edge of the headlining from between the windlace and the headlining retainer. Hold the edge of the headlining with one hand, then insert the rounded and smooth end of a putty knife blade upward to unhook the headlining from the retainer and uncover as required to locate the boss on the header.

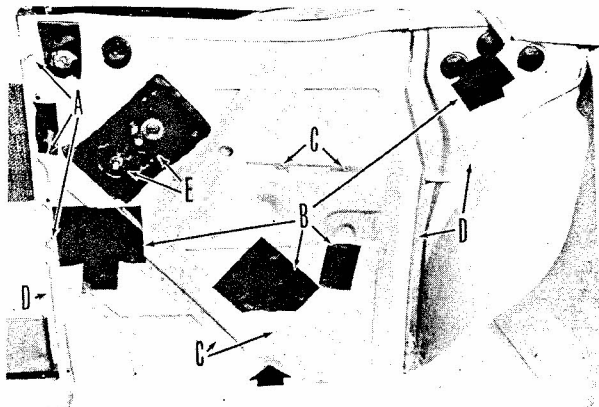
Fig. 3

Figure 3 illustrates the rear quarter inner panel of the J Models and points at which leakage may occur.

- A. Windlace Retainers
- B. Tape edges
- C. Edges of Channel and Arm Rest Nuts
- D. Pinch weld seams
- E. Regulator mounting plate and shaft

A. Seal the top and bottom windlace lanced retainers with Dum Dum from inside the quarter panel. Place tape over the center lanced hole from outside and seal with Dum Dum. The holes

B. Make sure that the tape seals-off the opening completely. Replace the tape, if required. If not, seal the edge of the tape with a suitable sealer.

C. Use a suitable sealer on the edges of the reinforcement channels and arm rest nuts.

To prevent water from building up within the reinforcement channels, drill a 1/4" hole, at the approximate location shown in Fig. 3, through the lower reinforcement and the inner body panel to provide a drain. Be sure to seal the hole in the reinforcement channel after drilling.

D. At the pinch weld seams or panel joints force a suitable sealer as far as possible into the seam.

E. Seal around the regulator mounting plate and shaft and, window run channel retaining screws with Dum Dum.

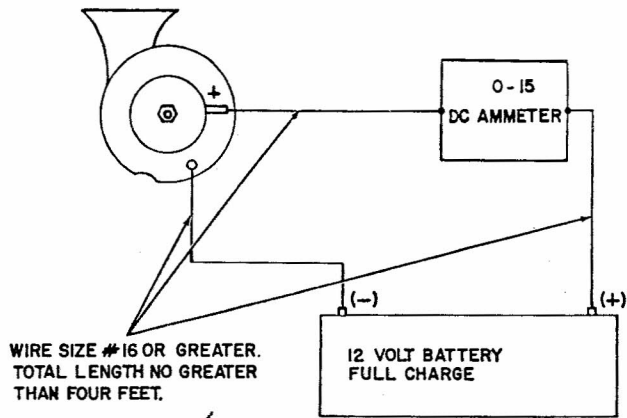
9-241 Fig. 4

horn as indicated in Fig. 4. CAUTION - The positive lead must be connected to the horn terminal.

b. After the connections are made as indicated in Fig. 4, firmly press the positive lead against the horn lead and observe the ammeter reading. Hold only long enough to observe the current indicated on the ammeter.

If the ammeter reading is 0 to 7 amperes -- Turn the current adjusting nut counterclockwise until horn draws approximately 9 - 10 amps. Between 7.5 to 10.5 amperes, the horn should

If the ammeter reading is 11.5 amperes or more -- turn the current adjusting nut clockwise until the horn current is approximately 9 - 10 amps. If the horn fails to adjust, replace.

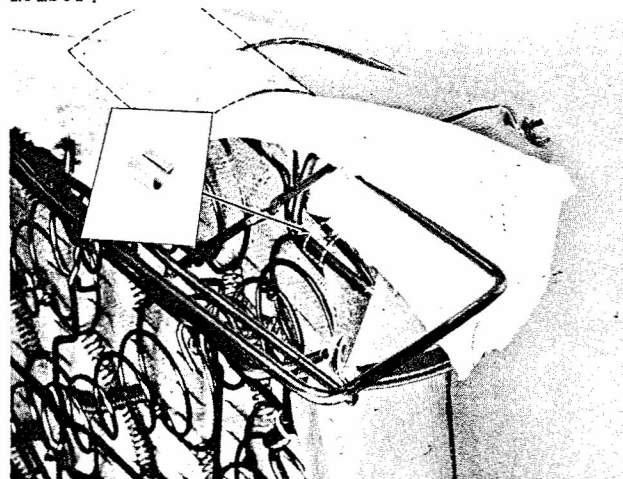
Fig. 5 15288-8

In some instances the clips which hold the spring assembly in position in the front seat cushion on 1958 two-door models may have loosened to permit one or both of the following conditions:

- A) Fore and aft movement of the top of the cushion
- B) Irregular appearance along the side rear top edge of the cushion trim cover.

When this condition is found remove the hog rings from the cushion cover and uncover the spring assembly as shown in Fig. 5 or as required.

To correct the fore and aft movement, install a second clip as indicated in Fig. 5. This clip may be fabricated from a piece of sheet metal (3/64" x 5/8" x 1-5/8") or the two wire frame members may be taped together securely. Make sure that the flat side of the top rim wire is directly on top of the round frame member.

To correct the irregular appearance along the side rear top edge of the cushion trim cover, fold the padding and/or sponge rubber from the cushion cover in the area indicated by the dotted lines in Fig. 5 and extend it rearward. Then secure it to the assembly with hog rings. Use two hog rings on the top and one on the rear edge of the frame.

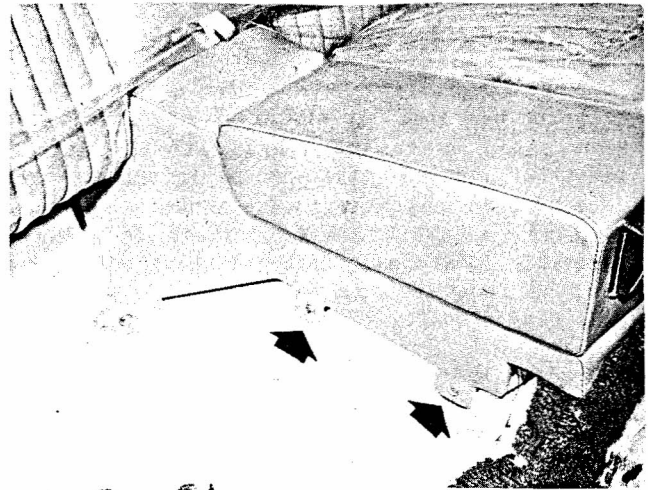
Fig. 6

In early production 58L K9 models, the screws which attach the center arm rest to the floor pan at the right side (see Fig. 6) may extend through far enough to cause interference with the propeller shaft.

To prevent this interference, remove the two screws and drill out the two holes to take 3/16" bolts. Install the bolts from below, with the heads of the bolts on the underneath side of the floor pan. Install lock washers and nuts on the bolts and when properly tightened, cut off the end of the bolt flush with the nut. It is only necessary to remove the right side cushion to perform this operation.

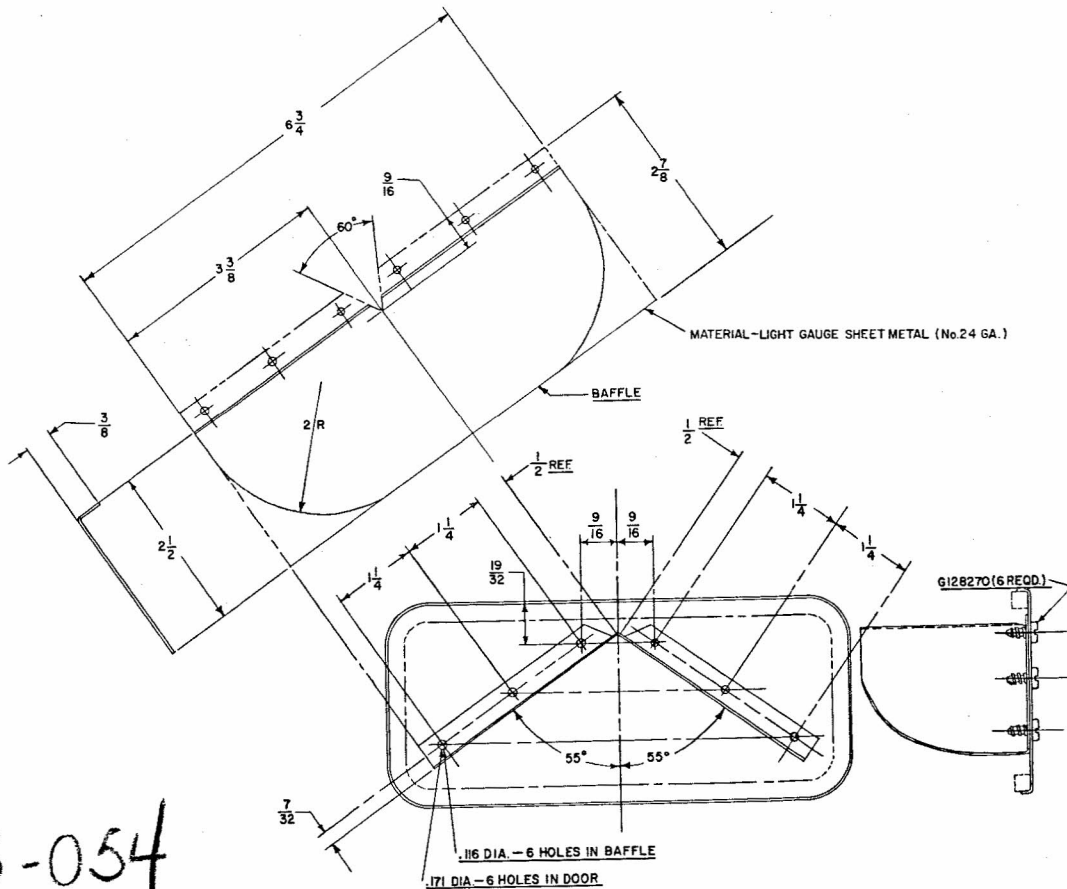
Fig. 7

We have received occasional complaints on trucks equipped with a Climatizer, that too much heat is directed onto the driver's foot and not enough heat to the passenger side of the cab. A baffle, which can be readily made in your shop, can be installed on the Climatizer door to divide the air flow so that more heated air is deflected to the passenger side of the cab. The dimensions and the installed position of the baffle are shown in Fig. 7.
