# Service Bulletin

NO. 337

SOUTH BEND 27, INDIANA

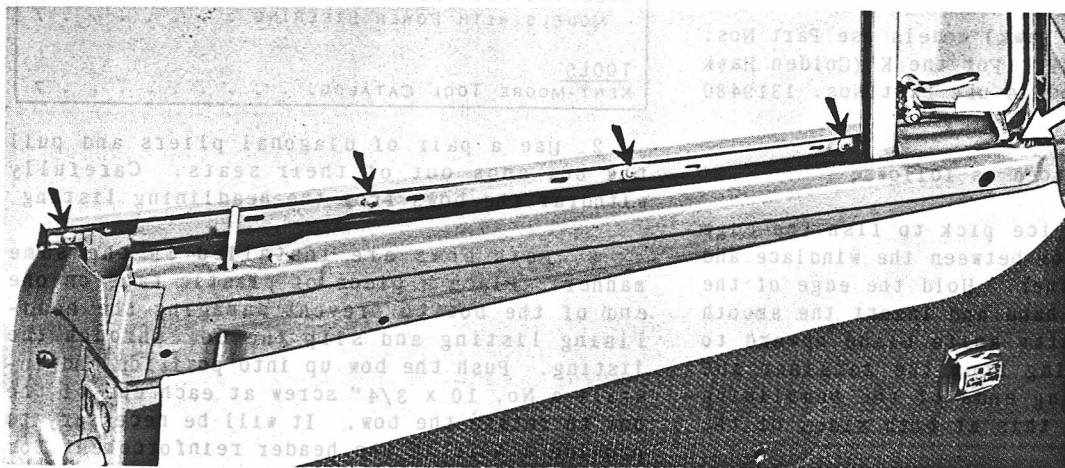
Fig. 1

screws in that it is a course thread screw. Then remove the remaining screws indicated by the arrows and remove the moulding.

Remove the window lower stop and bracket assembly. Then, lower the window as required to permit removal of the window weatherseal (fuzz strip). Remove the weatherseal. Then, remove the front screw below the ventilator window, turn back the rubber ventilator weather-strip which will expose a hole to provide access to the front screw. (See Fig. 1) Note: This screw is different from the other moulding

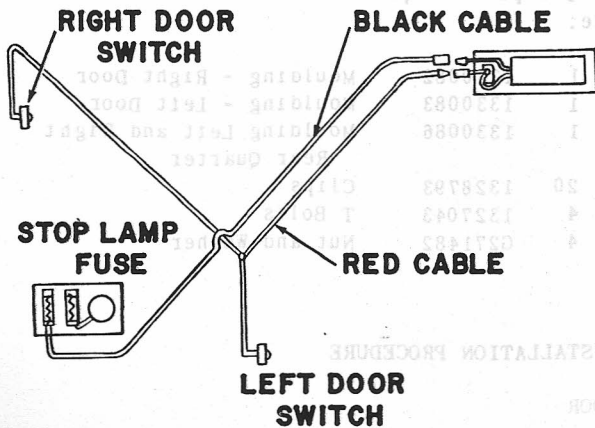
Fig. 2

8. Connect the black cable end to the terminal on the fuse block. See Fig. 2. Use screw, Part No. G-122159 and lock washer, Part No. 121752.

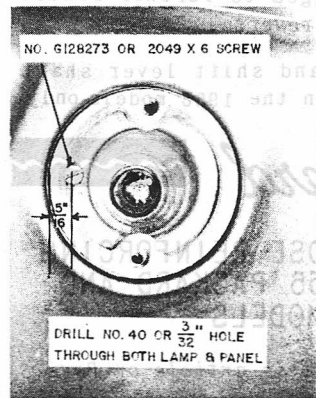
Fig. 3

A condition of poor ground can be corrected by the installation of a No. G128273 or 2049x6 Screw at a point 5/16" from the outer edge of the light housing as shown in Fig. 3.

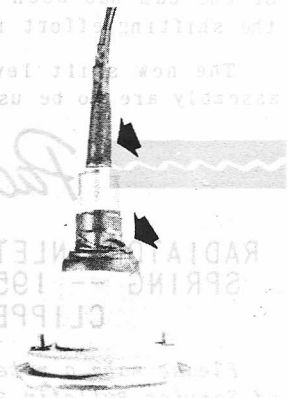
Fig. 4

A condition of water in the light housing can be corrected by the use of electrician's tape, applied at the points indicated by the arrows in Fig. 4. The lens gasket should also be checked for proper installation.
