Service Bulletin

FEBRUARY

1960

NO. 351

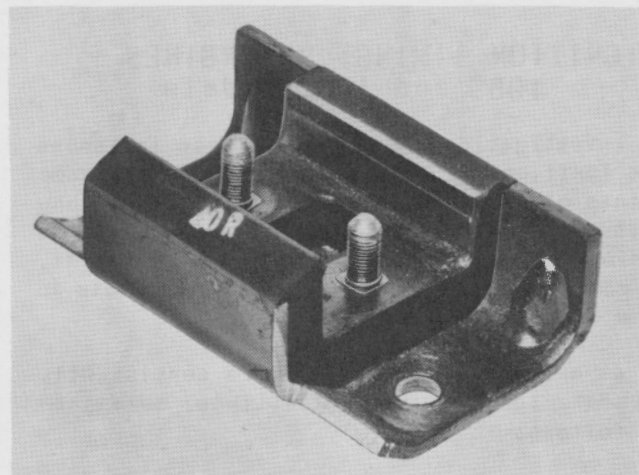
FIG. 1

When removing and replacing the clutch on models equipped with Engine Rear Support Insulator, Part No. 1550063 (see Fig 1), it is not necessary to remove the crossmember.

This new type rear support insulator, can be used on all S-Y1 Models.

To remove the clutch assembly, remove the two nuts and washers holding the insulator to the crossmember. Remove the two cap screws holding the insulator to the clutch housing. Raise the engine and slide the insulator forward and remove it from the crossmember. Push the clutch housing to the rear and rotate until the starter area is adjacent to the crossmember. Remove the pressure plate assembly from the flywheel. Then, the driven plate can readily be removed. To remove the pressure plate assembly, move it toward the starter area in the clutch housing and slip it out from between the clutch housing and engine rear plate. To install, reverse the procedure.

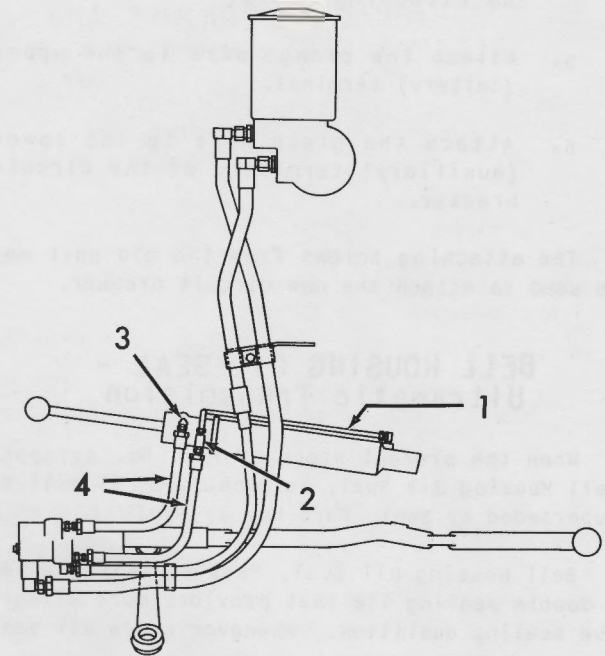
FIG. 2

When the supply of Power Steering Power Cylinder Assembly, Part No. 455211, is exhausted, it will be superseded by Power Cylinder Assembly, Part No. 443701.

To accommodate the installation of Power Cylinder 443701 as a replacement for 455211, the following parts will be included with Part No. 443701:

1. TUBE. 2. TEE FITTING. 3. ELBOW. 4. HOSE
