Service Bulletin

NO. 358

SOUTH BEND 27, INDIANA

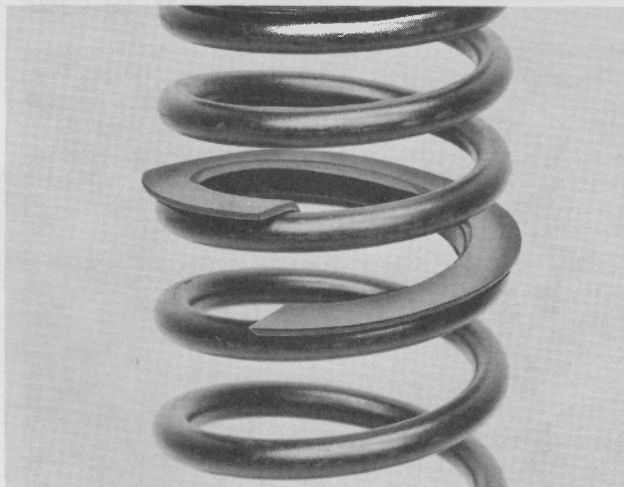
Fig. 1

FRONT SPRING NOISE—All 1959-60 Models

The installation of rubber Insulator, Part No. 526249, between the coils of the front spring will eliminate noise caused by coil-to-coil contact of the front spring which sometimes occurs under light load conditions.

Place the rubber insulator on top of the center coil with the inner flange of the insulator down (See Fig. 1) and then thread the insulator upward as far as possible. The weight of the car will hold the insulator in place. In some instances, it may be necessary to install two insulators to completely eliminate spring interference noise. The second insulator is installed in the same manner, and positioned adjacent to the first insulator.

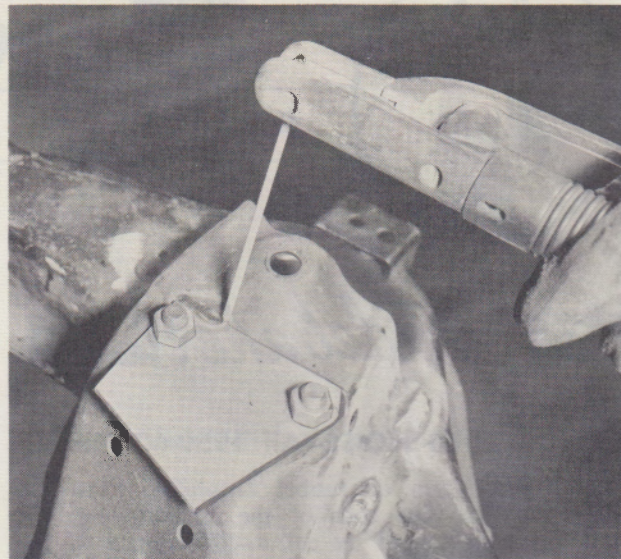
FIG. 3

We have received some field reports of front crossmembers cracking in the area of the upper control arm pivot shaft. In each instance the cars involved are used in severe type service and the cracking occurred at comparatively high mileages.

1. Remove the upper control arm pivot shaft.
2. Bolt the re-inforcing plate to the crossmember as shown in Fig. 2.
3. Arc weld the plate to the crossmember as shown in Fig. 3. Continue the weld around the part of the plate that sits flat on the crossmember.
4. Bend the remaining part of the plate down so that it will fit tight against the crossmember.
5. Continue the arc weld around the remaining portion of the plate. (See Fig. 4).
6. File the area of the re-inforcing plate on which the pivot shaft will be bolted as indicated in Fig. 5.
7. Install upper control arm pivot shaft.

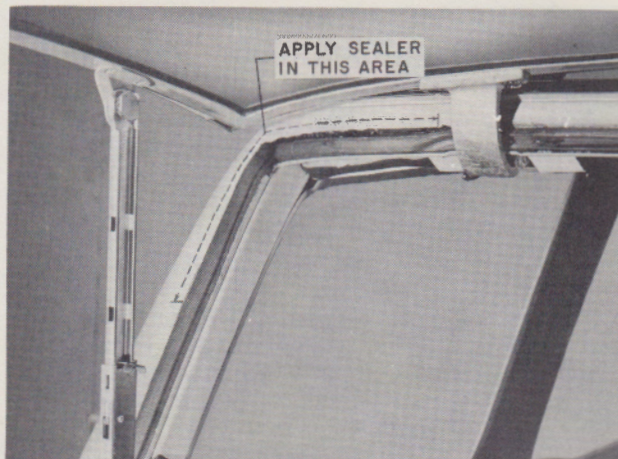
FIG. 6

Sealer is now being applied in production to the upper corners of the tail gate weatherstrip channel between the rubber weatherstrip and the outer edge of the channel. The sealer is applied after the weatherstrip is installed and prevents water from running behind the weatherstrip.

Apply a bead of Studebaker-Packard Weatherstrip Cement, Part No. SP-50045, between the rubber weatherstrip and the outer edge of the channel. The sealer should extend from the upper hinges to the corners, and then downward for a distance of approximately 5 inches. (See Fig. 6).

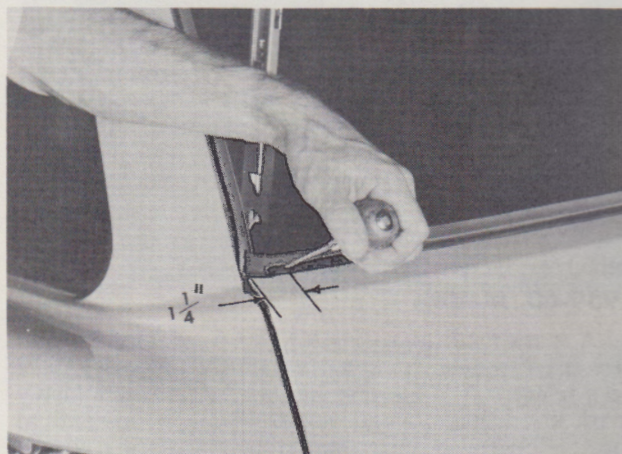
FIG. 7

A small screw and washer is now used to retain each end of the lower gate-to-upper gate rubber weatherstrip. The screws and washers are installed after the rubber is cemented to the gate.

1. If the rubber weatherstrip is loose, cement it firmly to the gate being certain the end sections of the rubber are properly located and cemented to the channel and to the end surfaces of the gate.
2. Punch or drill a 7/64" hole thru the rubber weatherstrip and thru the outer panel of the tail gate channel at the lower intersection of the vertical and horizontal section of the outer panel 1 1/4" from the outer end of the gate. (See Fig. 7).
3. Install the small screw, Part No. 2049 x 11G1—(No. 6—18 x 3/4 truss head) and flat washer, Part No. G103337 (5/32 x 3/8) in the punched hole and tighten the screw securely. (See Fig. 8).
4. Repeat steps 2 and 3 at the opposite end of the gate.

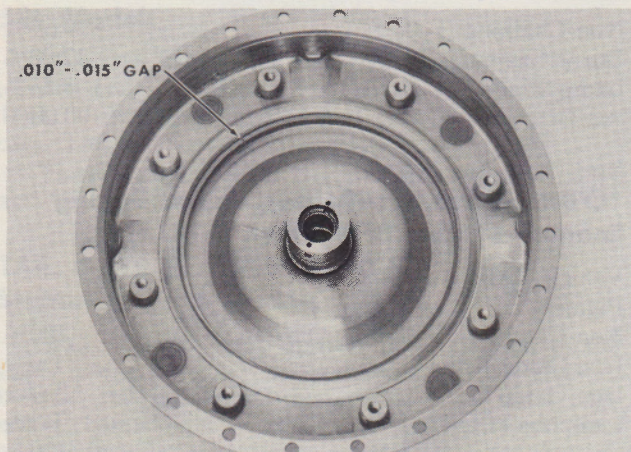
FIG. 9

An improper engagement or slow release of the direct drive clutch may be encountered following the reconditioning of the converter that includes installation of new inner and outer direct drive piston rings. It may also occur in a new service replacement assembly.

This malfunction may be caused by piston rings that are butting because of insufficient ring gap. It is recommended that all piston rings be checked for gap before installation. Each of the four outer rings should be checked for gap in the bore of the clutch housing. (See Fig. 9). File the ends as necessary to provide a gap of .010" - .015". Clean off all burrs or roughness caused by filing. Upon installation, make sure ring gaps are spaced so that no two gaps are in line.

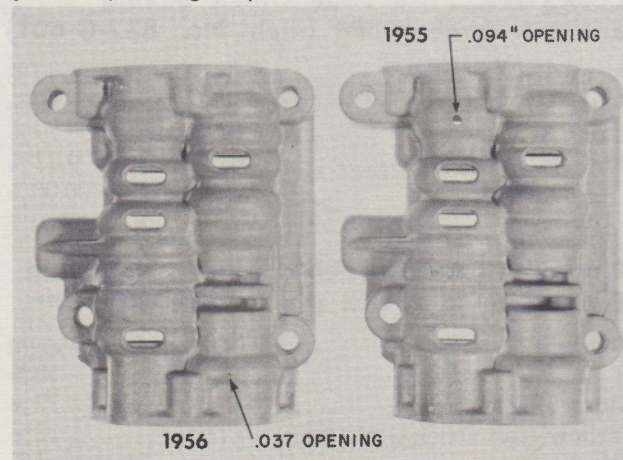
FIG. 11

The control valve body assemblies in the 1955 Twin-Ultramatic transmission are not interchangeable with the assemblies used on the 1956 Twin-Ultramatic transmissions.

They appear to be the same but, there are differences in calibration, vent, etc. that prevents their interchangeability. To interchange these assemblies upsets the shift pattern.

The 1955 assembly has a .094" vent opening, drill size No. 42, over the direct shift valve in the rear upper valve body. (See Fig. 11).

The 1956 valve body assembly has a .037" vent, drill size No. 63, located over the low high shift piston. (See Fig. 11).

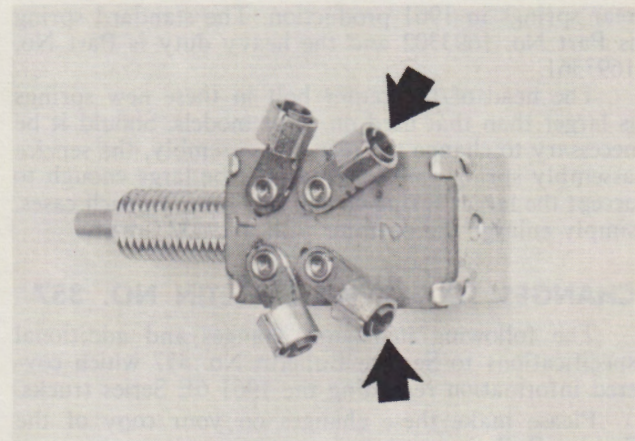
FIG. 12

We have received a few complaints regarding the automatic transmission down-shifting on light throttle application. In each instance it has been found that the wires to the kick-down switch were placed in the wrong terminal.

The correct method of connecting the kick-down switch on the 4E and 5E Series trucks is shown in Fig. 12.
