# THE HAWKEYE

## THE OFFICIAL NEWSLETTER OF THE 1956 STUDEBAKER GOLDEN HAWK INFORMATION EXCHANGE CLUB

SEPTEMBER 1990

**GOLDEN HAWK  
AUTOMATIC to TORQUEFLITE  
CONVERSION**

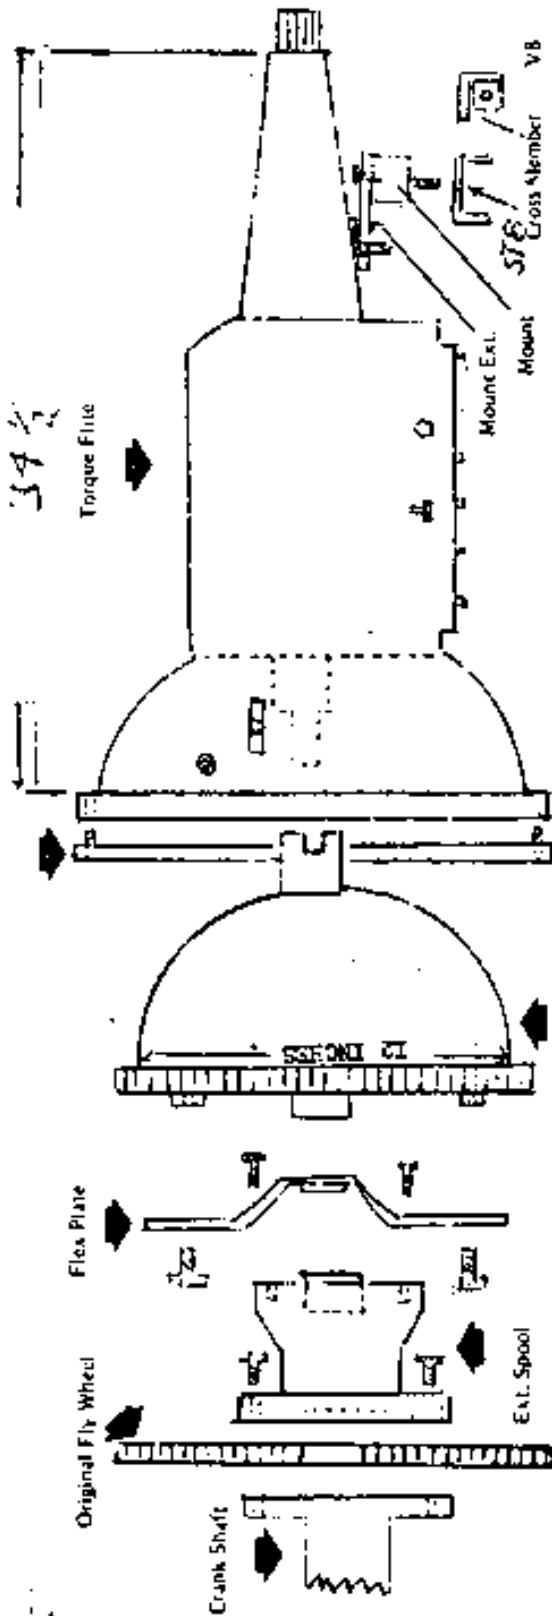
THE FOLLOWING CORRECTLY IDENTIFY THE CIV. 727 TORQUE FLITE (S) THIS SECTION THIRTY FOUR AND ONE HALF INCHES OVER-ALL THE TWO TOP BOLT HOLES IN BELL HOUSING ARE 7 3/4 INCHES CENTER TO CENTER THE CONVERTOR IS APPROX. 12 INCHES IN DIAM.

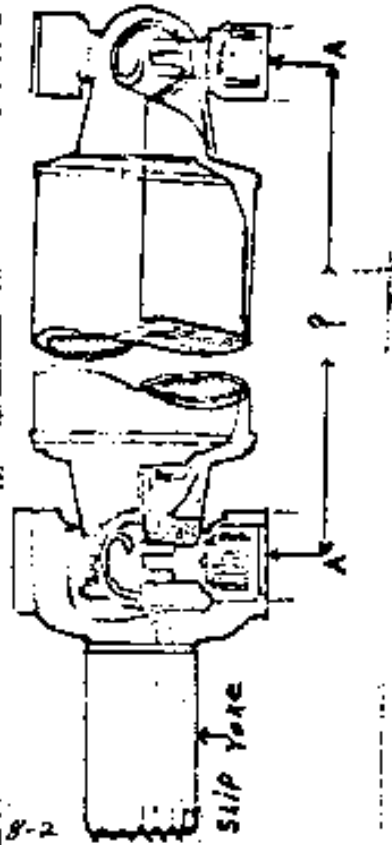
WITH SLIP YOKE IN TRANS. AS FAR AS POSSIBLE MEASURE FROM A TO A. DEDUCT 3/4 INCH, THIS WILL BE THE FINISH D LENGTH OF SHAFT.  
 NOTE: THE ORIGINAL REAR PACKARD U-JOINT FLANGE MUST BE USED ON THE CIV. SHAFT (NOTE A) OR THE SLIP YOKE SHD CAN BE ADAPTED TO PACKARD SHAFT.

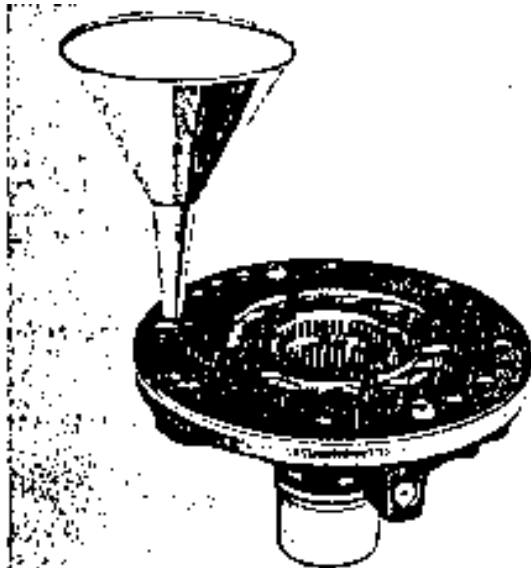
PB-198 FIG. 2

A few cases have been found of a restriction in the high range clutch oil passage in the front pump of Ultramatic transmissions. This restriction is caused by the core shifting when the pump housings are cast. If the passage is restricted, possible engine raceaway on low range converter to high range converter upshifts may occur, or the high range clutch may burn out prematurely.

Place the complete front pump assembly in a shallow pan with the pump plate upward and in a horizontal position. Use a small funnel with the end reworked to obtain a close fit in the high range oil circuit hole of the pump plate as shown in Fig. 2.

If it requires more than 2 minutes and 15 seconds for passage of the 1/2 pint of fluid, it will indicate the passage is restricted and the pump should be replaced. Repeat the test if restriction is indicated before replacing the pump.

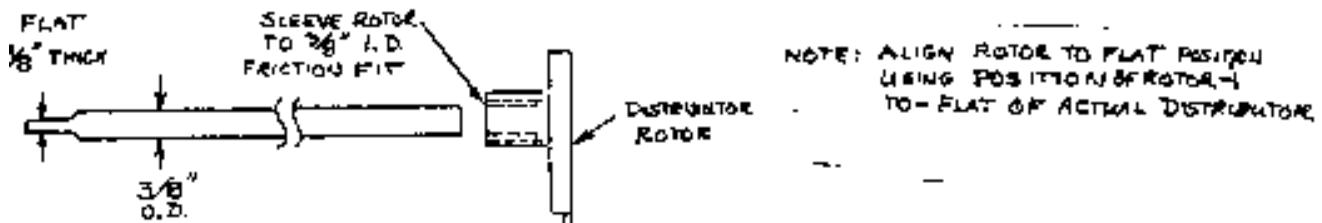
**Notes on Distributor Replacement** - I recently had a distributor failure on a 62 Hawk. I pulled the distributor and utilized a local shop to rebuild the unit. To reinstall the distributor, I rotated the engine to place the timing on the "IGN" mark. This required that I pull the left bank valve cover off so that I could ensure that I was on No. 1 cylinder by observing that the No. 1 cylinder intake valve had closed prior to coming up on the "IGN" mark on the damper wheel. When I tried to install the distributor, I found that I could not fully seat the distributor because the slot for the oil pump drive did not align with the distributor shaft oil pump drive.

The shop manual instructions say to place the distributor in and if it doesn't align with the oil pump drive slot to put slight down pressure on the distributor and crank the engine using the starter motor. The rotation of the distributor together with a slight downward pressure will then allow the oil pump shaft of the distributor to engage the slot of the oil pump. I did not like that solution as it destroyed the timing relationship that I had verified.

So I made my own tool to allow me to rotate the oil pump slot to match the Cylinder No. 1 position of the distributor shaft while the engine is in the No. 1 firing position ("IGN" on the damper wheel). A drawing of the tool that I built is as shown below. The tool also allows one to pre-oil the engine by using a 3/8 in. drive drill motor to drive the oil pump when the distributor is removed. The drill motor must have CCW rotation (same as distributor rotation) and one must verify that oil pressure is achieved when turning the oil pump using the shaft driven by the drill motor.
