56J ONLY

THE PERIODIC NEWSLETTER OF THE 1956 STUDEBAKER GOLDEN HAWK OWNERS CLUB

NUMBER 009

DECEMBER 1990

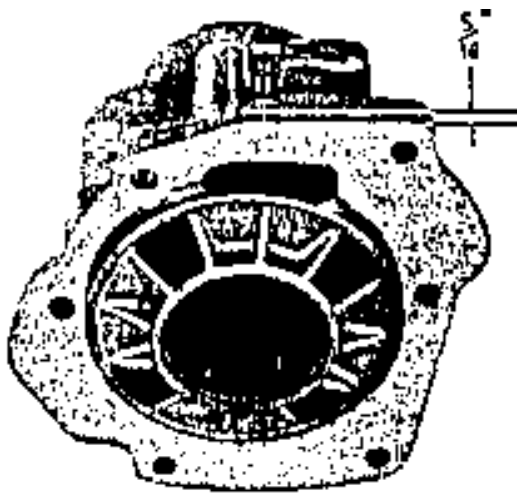
Fig. 4

A condition of oil loss through the breather in the 56J Ultramatic transmission may be encountered when accelerating to high speeds in Low Range Converter, or after downshifting from Direct Drive to Low Range Converter at high speeds.

First, check the oil level in the transmission to be certain that the level is not too high. If the oil level is correct, it will be necessary to relocate the breather.

1. Remove the transmission rear extension housing assembly and remove the shaft assembly from the housing.
2. Locate a point on top of the extension housing 1 1/2" left of the upper right bolt hole in the housing and 3/16" rearward from the machined face of the housing. (See Fig. 4)
3. At this point, drill a 21/64" hole down through the upper part of the housing. Be careful not to drill into or damage the pressed-in aluminum spider. Tap out the hole with a 1/8" pipe tap. Then, clean the housing thoroughly.

4. Remove the vertical portion of the present breather and install it in the capped hole in the rear of the extension housing.
5. Remove the elbow of the hatching from the transmission case and install a 1/8" pipe plug.
6. Assemble and reinstall the rear extension housing assembly.

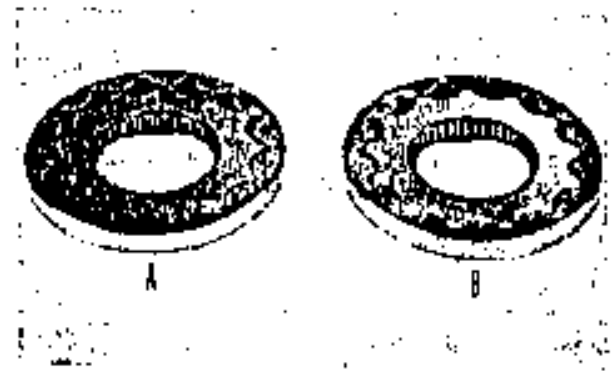
The front oil pump rotor ('A' in FIG. 3) having 20 internal splines is used in the 54th

A. 20 Spline Rotor

B. 40 Spline Rotor

Series Gear-Start, 55th and early 56th Series, 'B' shown in Fig. 3 to the 40 tooth splined rotor, Part No. 6489387.

When the converter shaft assembly of the gear-start type Ultramatic transmission is replaced because of worn or stripped splines, it is advisable to check the front oil pump rotor. If the rotor is one having 20 teeth in the driving section, replace it with one having 40 teeth, Part No. 6489387. Whenever it is necessary to replace both the shaft and rotor, it is advisable to order either Part No. 6484523, Rotor and Shaft Kit, or Part No. 6484524, Pump Assembly and Shaft Kit. This will insure lon-

ger service life of the converter shaft by providing a better fit of the mating rotor splines.

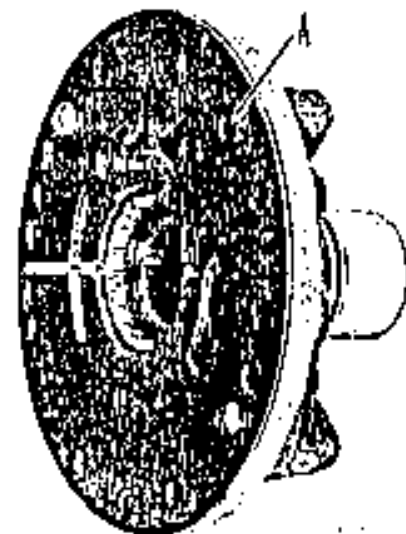
Fig. 4

On the 54th Series Gear-Start, all 55th and early 56th Series Packard and Clipper models, the oil pressure for the direct drive clutch came out of a passage on the front side of the pump. See A, FIG. 4. The oil pressure was

A. Direct Drive Clutch Oil Pressure Passage

directed through a passage in the Bell housing then past the open splines in the rotor to the input shaft.

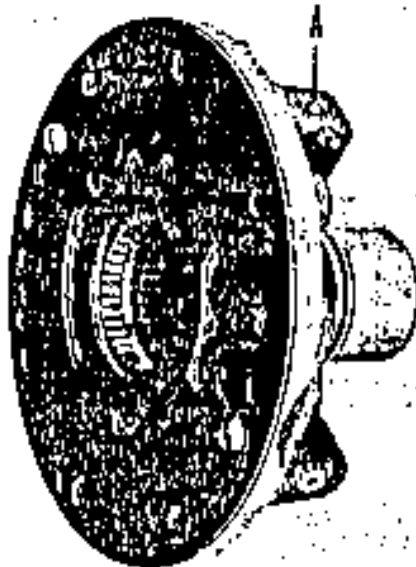
Fig. 5

On the 56th Series Packard Transmission after transmission serial number 5-40489, and all Studebaker 581 Golden Hawks, the front oil pumps have the direct drive clutch oil passage in the rear side of the pump. See at A in Fig. 5. The outlet for this passage is in between the two bushings inside the pump hub. Note that there is no oil passage in the front plate. However, this type pump originally had the 36 tooth splined rotor. (40 tooth shown in the illustration)

A. Direct Drive Clutch Oil Passage Passage
