56J ONLY

THE PERIODIC NEWSLETTER OF THE 1956 STUDEBAKER GOLDEN HAWK OWNERS CLUB

DECEMBER 1990

MORE ON THE TWIN ULTRAMATIC

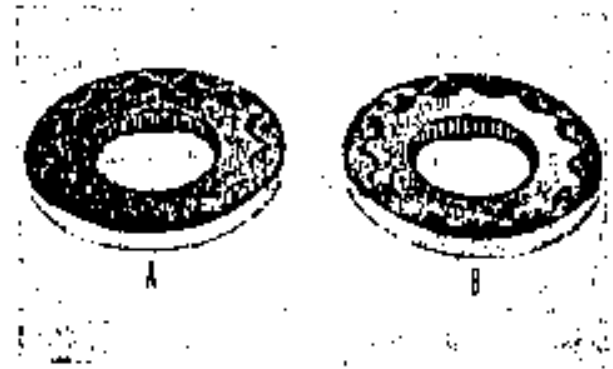
The front oil pump rotor ('A' in FIG. 3) having 20 internal splines is used in the 54th

A. 20 Spline Rotor

B. 40 Spline Rotor

Series Gear-Start, 55th and early 56th Series, 'B' shown in Fig. 3 to the 40 tooth splined rotor, Part No. 6489387.

When the converter shaft assembly of the gear-start type Ultramatic transmission is replaced because of worn or stripped splines, it is advisable to check the front oil pump rotor. If the rotor is one having 20 teeth in the driving section, replace it with one having 40 teeth, Part No. 6489387. Whenever it is necessary to replace both the shaft and rotor, it is advisable to order either Part No. 6484523, Rotor and Shaft Kit, or Part No. 6484524, Pump Assembly and Shaft Kit. This will insure lon-

ger service life of the converter shaft by providing a better fit of the mating rotor splines.

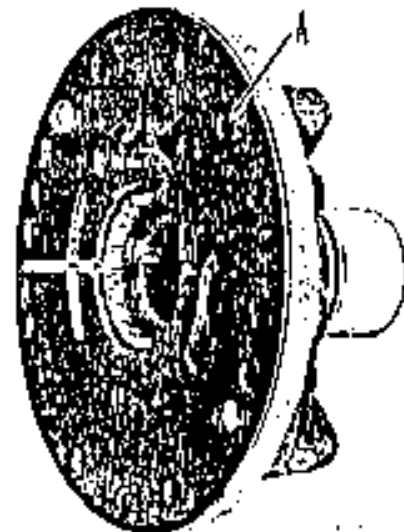
Fig. 4

On the 54th Series Gear-Start, all 55th and early 56th Series Packard and Clipper models, the oil pressure for the direct drive clutch came out of a passage on the front side of the pump. See A, FIG. 4. The oil pressure was

A. Direct Drive Clutch Oil Pressure Passage

directed through a passage in the Bell housing then past the open splines in the rotor to the input shaft.
