# 56J ONLY

## THE PERIODIC NEWSLETTER OF THE 1956 STUDEBAKER GOLDEN HAWK OWNERS CLUB

DECEMBER 1990

### MORE ON THE TWIN ULTRAMATIC

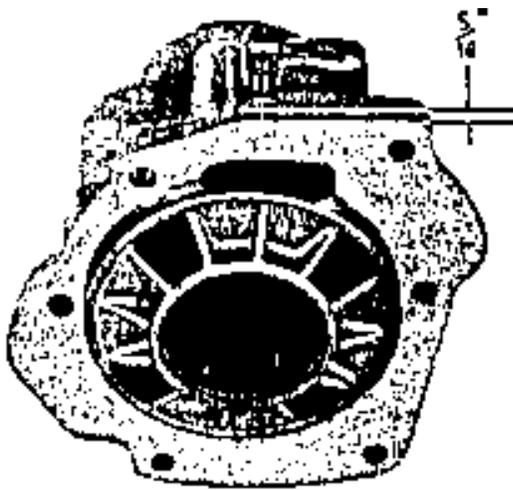
Fig. 4

A condition of oil loss through the breather in the 56J Ultramatic transmission may be encountered when accelerating to high speeds in Low Range Converter, or after downshifting from Direct Drive to Low Range Converter at high speeds.

First, check the oil level in the transmission to be certain that the level is not too high. If the oil level is correct, it will be necessary to relocate the breather.

1. Remove the transmission rear extension housing assembly and remove the shaft assembly from the housing.
2. Locate a point on top of the extension housing 1 1/2" left of the upper right bolt hole in the housing and 3/16" rearward from the machined face of the housing. (See Fig. 4)
3. At this point, drill a 21/64" hole down through the upper part of the housing. Be careful not to drill into or damage the pressed-in aluminum spider. Tap out the hole with a 1/8" pipe tap. Then, clean the housing thoroughly.

4. Remove the vertical portion of the present breather and install it in the capped hole in the rear of the extension housing.
5. Remove the elbow of the hatching from the transmission case and install a 1/8" pipe plug.
6. Assemble and reinstall the rear extension housing assembly.

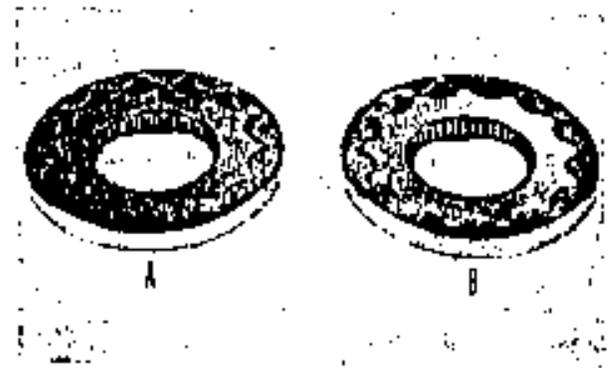
The front oil pump rotor ('A' in FIG. 3) having 20 internal splines is used in the 54th

- A. 20 Spline Rotor  
B. 40 Spline Rotor

Series Gear-Start, 55th and early 56th Series, 'B' shown in Fig. 3 to the 40 tooth splined rotor, Part No. 6489387.

When the converter shaft assembly of the gear-start type Ultramatic transmission is replaced because of worn or stripped splines, it is advisable to check the front oil pump rotor. If the rotor is one having 20 teeth in the driving section, replace it with one having 40 teeth, Part No. 6489387. Whenever it is necessary to replace both the shaft and rotor, it is advisable to order either Part No. 6484523, Rotor and Shaft Kit, or Part No. 6484524, Pump Assembly and Shaft Kit. This will insure lon-

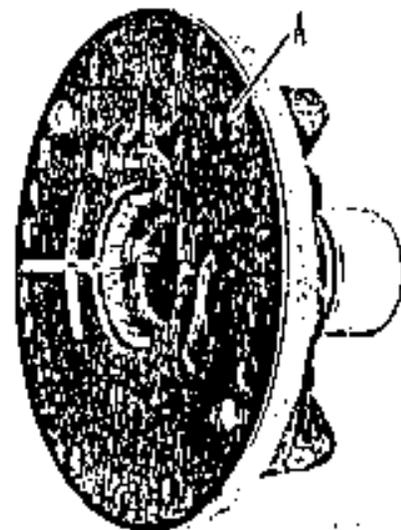
Fig. 4

On the 54th Series Gear-Start, all 55th and early 56th Series Packard and Clipper models, the oil pressure for the direct drive clutch came out of a passage on the front side of the pump. See A, FIG. 4. The oil pressure was

- A. Direct Drive Clutch Oil Pressure Passage

directed through a passage in the Bell housing then past the open splines in the rotor to the input shaft.

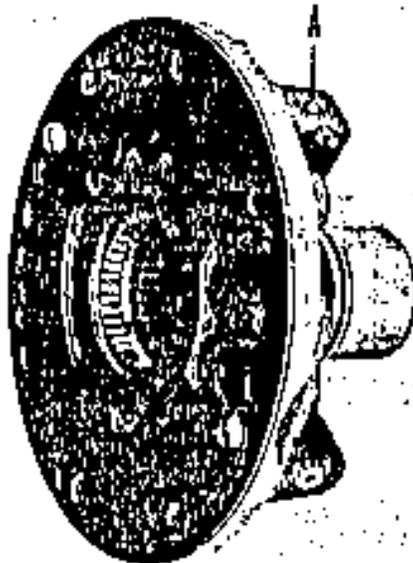
Fig. 5

On the 56th Series Packard Transmission after transmission serial number 5-40489, and all Studebaker 581 Golden Hawks, the front oil pumps have the direct drive clutch oil passage in the rear side of the pump. See at A in Fig. 5. The outlet for this passage is in between the two bushings inside the pump hub. Note that there is no oil passage in the front plate. However, this type pump originally had the 36 tooth splined rotor. (40 tooth shown in the illustration)

A. Direct Drive Clutch Oil Passage Passage

has 40 splines. Therefore, it will be necessary to drill six 1/8" holes evenly spaced through the annular groove just back of the splines in the converter shaft to provide an oil passage to the direct drive clutch. "See arrow Fig. 6." This also applies when replacing the rotor assembly. When necessary to drill holes in the groove of the converter shaft, remove burrs from the edges of the 1/8" holes and internal bushing after drilling.

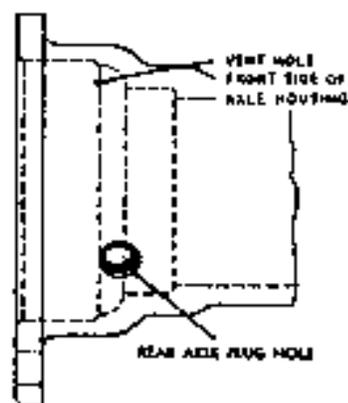
FIG. 23

Rear Axle Shaft Bearings—All Models  
Wheel Bearing Lubricant—10,000 miles (14-89 lbs.)  
Make sure vent hole is open
