56J ONLY

THE PERIODIC NEWSLETTER OF THE 1956 STUDEBAKER GOLDEN HAWK OWNERS CLUB

NUMBER 009

DECEMBER 1990

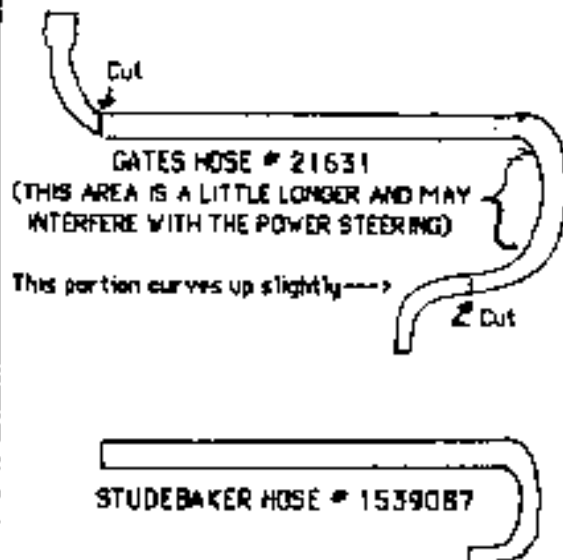
FIGURE 1.

Enclosed are your Studebaker hoses along with Gates aftermarket hoses 20637 and 21631. The Gates hoses have been compared to your samples and are as similar in configuration as possible. Hose 20637 will probably have to be cut slightly to fit. (NOTE: This is the lower hose and is nearly identical in shape to the original Studebaker hose I installed this one on my car, although it was a very tight fit on the water manifold.) The other hose, 21631, will have to be cut an or close to the indicated areas and one end is 1 1/2" I.D. compared to the 1 9/16" I.D. on the straight arm of the sample. I do not anticipate a problem with the I.D. difference. (NOTE: This is the upper hose. I have not tried this one yet. See Figure 1 below for additional information.)

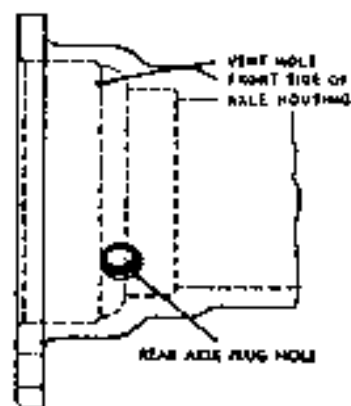
FIG. 23

Rear Axle Shaft Bearings—All Models
Wheel Bearing Lubricant—10,000 miles (14-89 lbs.)
Make sure vent hole is open
