# 56J ONLY

## THE PERIODIC NEWSLETTER OF THE 1956 STUDEBAKER GOLDEN HAWK OWNERS CLUB

DECEMBER 1990

### MORE ON THE TWIN ULTRAMATIC

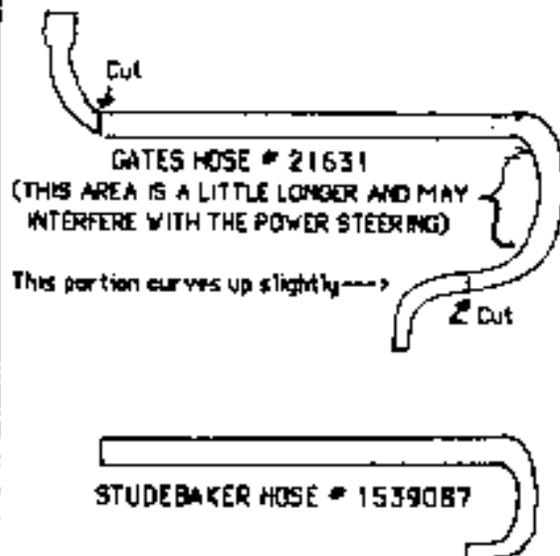
FIGURE 1. ambrogio@ms

*Enclosed are your Studebaker hoses along with Gates aftermarket hoses 20637 and 21631. The Gates hoses have been compared to your samples and are as similar in configuration as possible. Hose 20637 will probably have to be cut slightly to fit. (NOTE: This is the lower hose and is nearly identical in shape to the original Studebaker hose I installed this one on my car, although it was a very tight fit on the water manifold.) The other hose, 21631, will have to be cut an or close to the indicated areas and one end is 1 1/2" I.D. compared to the 1 9/16" I.D. on the straight arm of the sample. I do not anticipate a problem with the I.D. difference. (NOTE: This is the upper hose. I have not tried this one yet. See Figure 1 below for additional information.)*
