Studebaker

SERVICE BULLETIN

NO. 315

1956

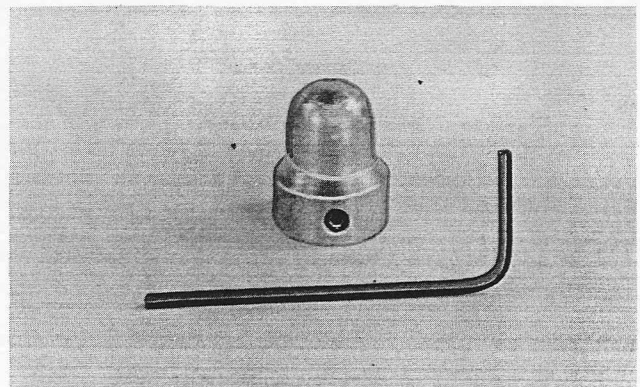
FIG. 4

The J-5978 Checking Tool can be modified so that it can be used on the later type lifters by grinding down the lower jaw of the tool as shown in Fig. 3 and using an Adapter Kit J-5978-6 (see Fig. 4). Grind the two ears of the lower jaw down to a $5/32$ " thickness and back $5/8$ " as shown.
